RAILROAD COMMISSION OF TEXAS SURFACE MINING AND RECLAMATION DIVISION

URANIUM EXPLORATION INSPECTION REPORT

Mine Name: Weesatch Project Permit Number: 123
 Permittee: Uranium Energy Corporation (UEC) County: Goliad
 Industry Representative(s) Present: Mike O'Leary
 Inspector: Murphy Hawkins, Michael Gay, Jon Brandt, Dean Poth Date of Inspection: March 7-9, 2007

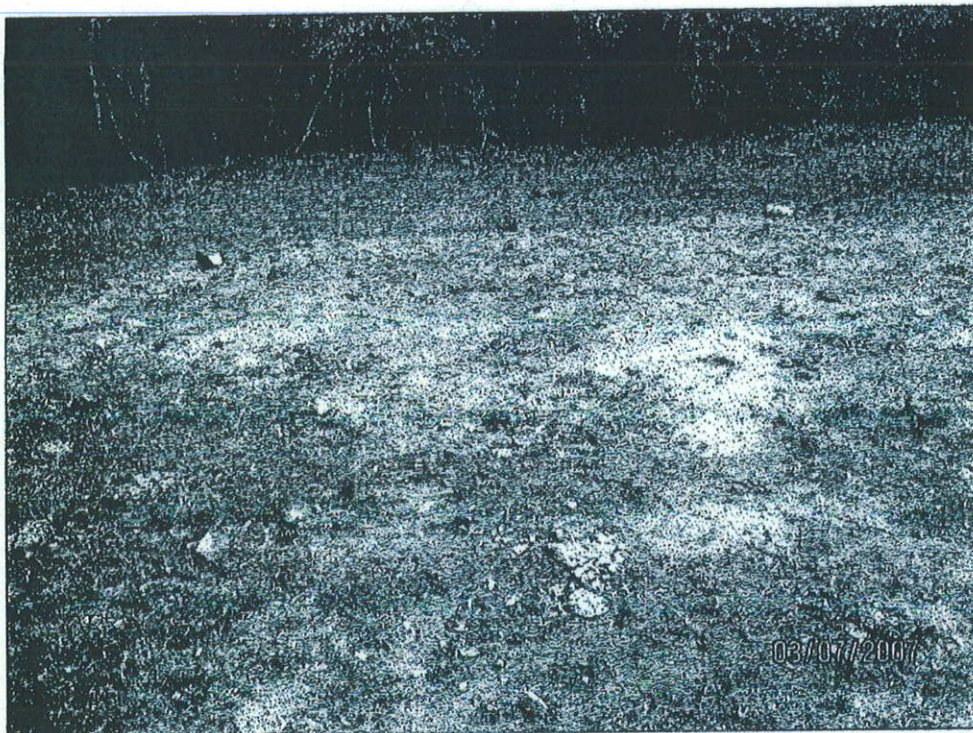
In Section IV A of the application, UEC states that, during drill site preparations, topsoil will be segregated from other soils and saved and later re-distributed. Topsoil was not re-distributed on the top of the majority of the drill sites inspected. In the 117 borehole sites inspected 74 were not fully re-topsoiled. Site 32892-84 (see photograph 3) exemplifies this drill site reclamation failure. Site 32892-84 is covered with a gray subsoil with little or no topsoil evident.

Photograph 3: Borehole 32892-84, Grey Subsoil on Surface

Based on observations made during this field inspection I believed that UEC was not in compliance with their Exploration Permit and the Regulations and issued Notice of Violation 080A. The Notice of Violation requires that UEC install a concrete surface plug at all sites, mark the exact location of each borehole for verification by the Commission, and remove all drilling mud, cuttings, cement and other debris burying it with no less than one foot of topsoil. UEC is directed to complete the remedial action by April 12, 2007.

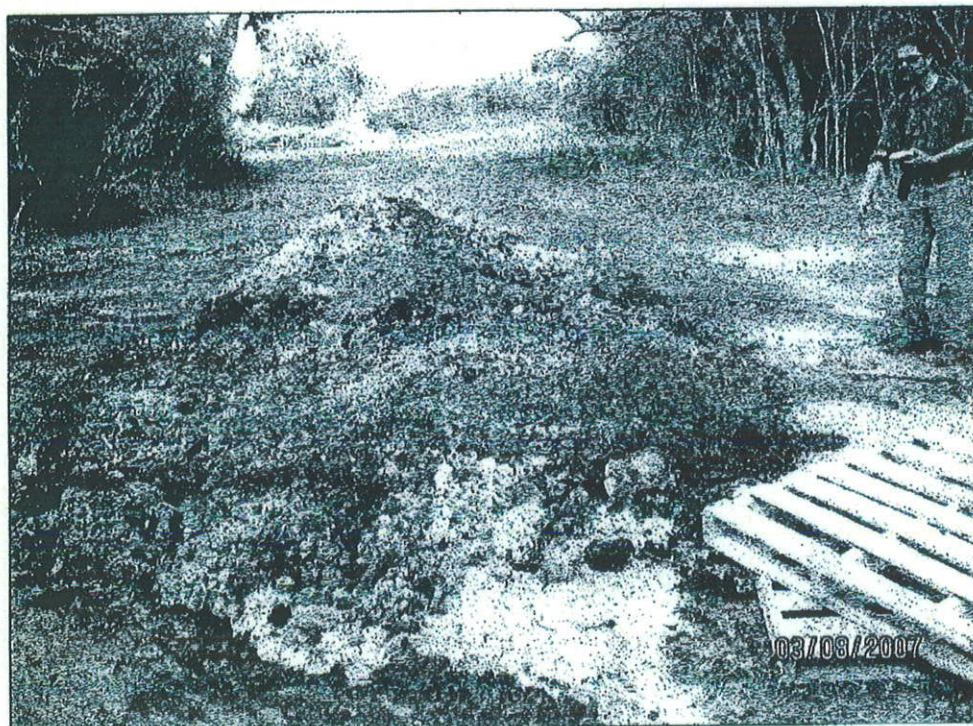
In Section IV A of the application, UEC states that mud pits will be allowed to dry before being backfilled with subsoil and cuttings. This drying aids in preventing excursions semi-solid drilling fluids. I observed at the active sites that drilling pits were being backfilled very quickly after the hole was logged with no drying period (see photograph 4). This process caused lighter drilling liquids to be crowded out of the pit and flow on to the surface. Evidence of this reclamation failure was also evident in the several older drill holes including Borehole 32892-84 where drilling fluids or cuttings were found on the surface (see photograph 5).

Photograph 4: Drilling fluids excursion from mud pit

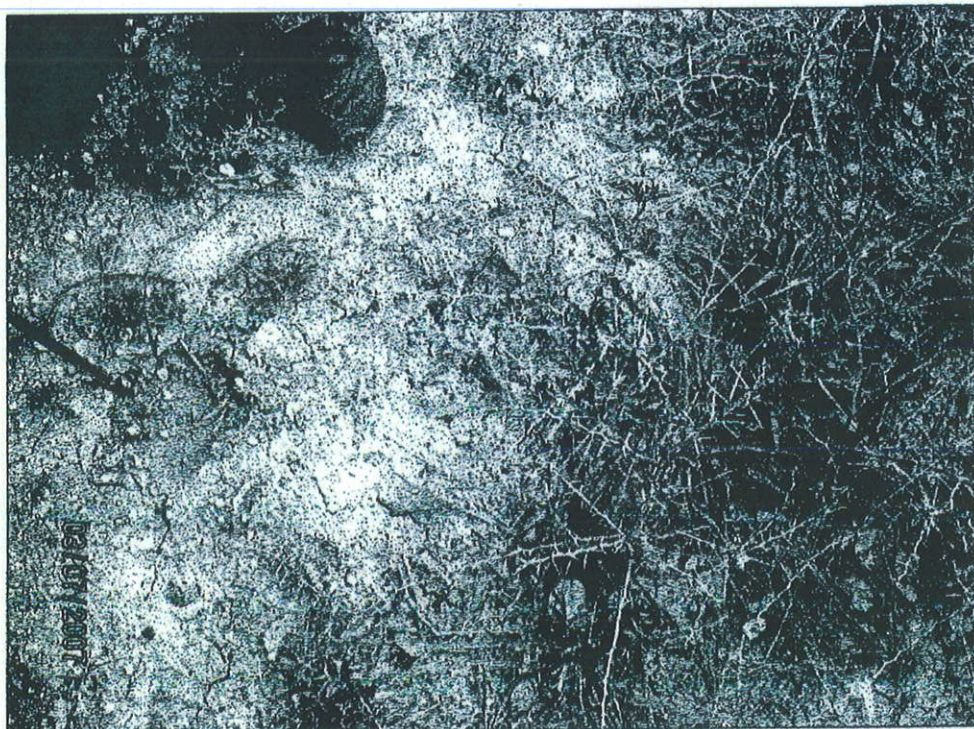
Photograph 5: Borehole 32892-84 cuttings from pit on surface

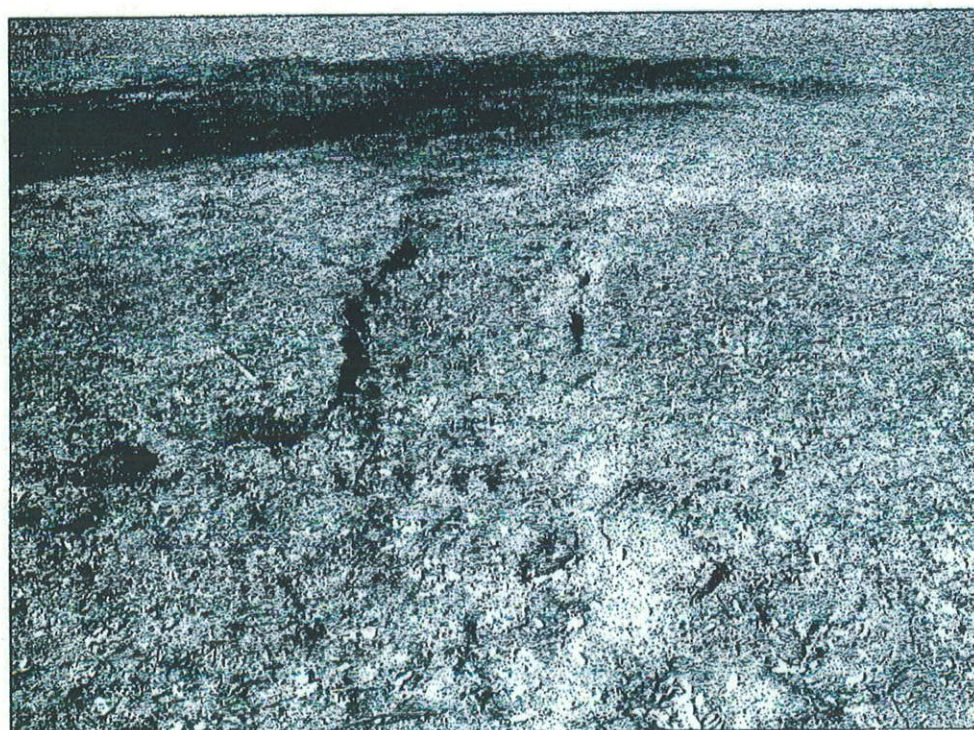
In Section IV A of the application, UEC states that mud pit areas will be backfilled to above grade to allow for settling. This precaution is designed to prevent the formation of depressions in the pasturelands drilled. Eleven of the 117 boreholes inspected had depression areas forming over the mud pits. Borehole 32201-N40 is an example of this backfilling failure (see photograph 6).

Photograph 6: Borehole 32201-N40 Mud Pit Depression

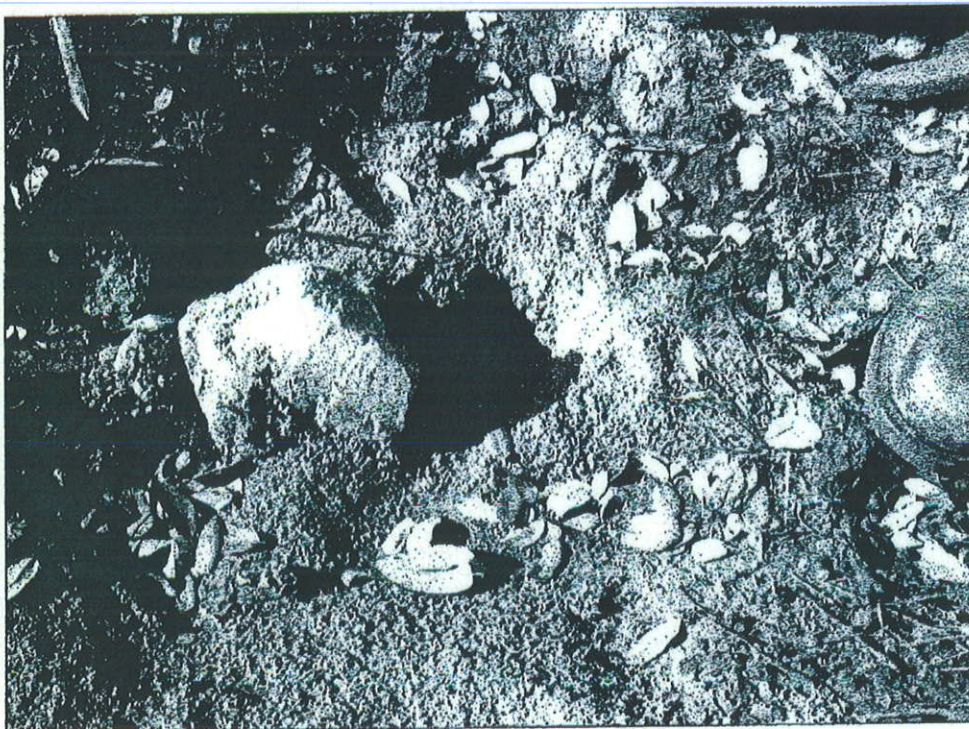
As required by the Commission's permit issuance letter, each borehole drilled in this project is required to have a ten-foot surface plug located three feet below the surface. The majority of the borehole locations were unable to be located for verification. Of the fourteen boreholes located, five were found to be open to the surface with the cement plug estimated to be greater than 20 feet below the surface and the remainder of the plugs found were between 0 and 18 inches below the surface. Borehole 32201-N38 (see photograph 7) is an example of this plugging failure.

Photograph 7: Borehole 32201-N38 No Surface Plug

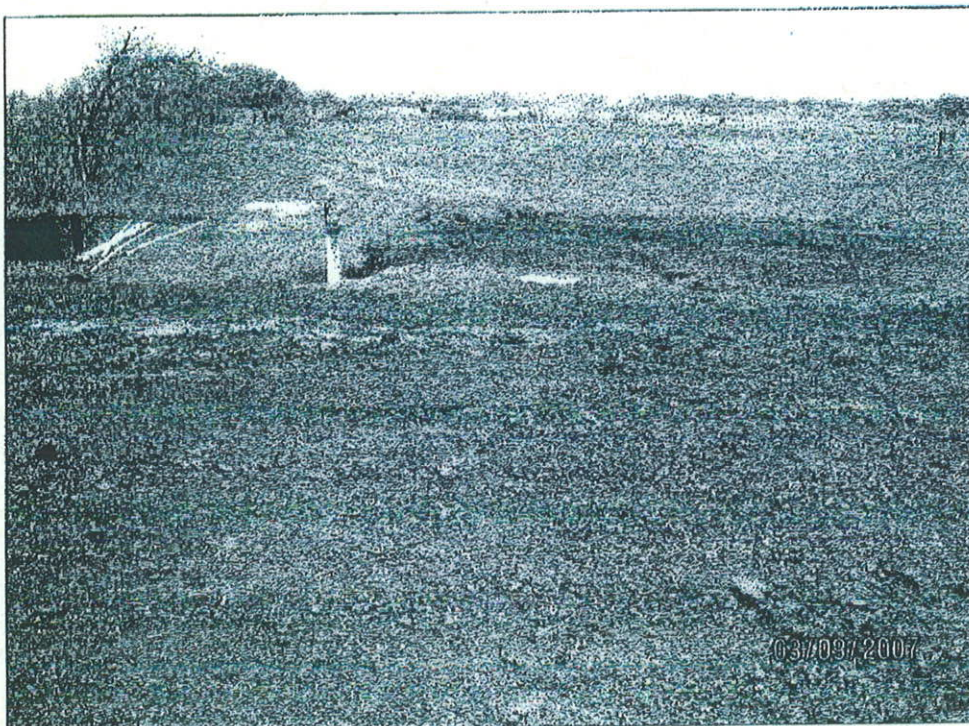
Several sites were inspected where the surface reclamation had been done in accordance with the performance standards contained in UEC's Permit No. 123 (see photographs 8 and 9).

Photograph 8: Jacobs Water Well Reclamation Site
